Inspection Report

Subject Property: 3631 Lawn Avenue, Saint Louis, MO 63109

Inspection Date: 09/22/2005

BenchMark Home Inspections, L.L.C

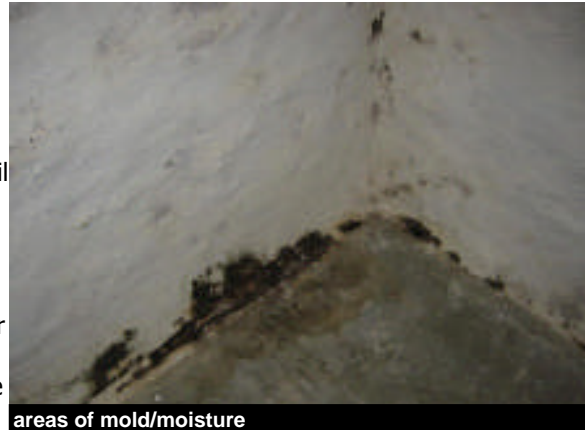
Further Evaluation: There was evidence of what appeared to be mold/mildew or fungus present at the small area of the front basement wall under the front porch. This inspection does not include testing for mold type or toxicity. Further testing is recommended and needed to determine type and toxicity levels. Health hazards may exist from what appears as a simple mold. Testing for airborne mold is also excluded from this inspection. We recommend further evaluation by a mold specialist or environmental lab if a concern to the client.

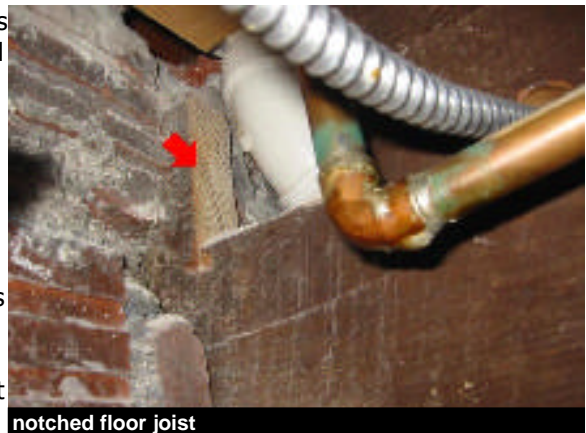
Repair: As viewed from the unfinished basement on right side under the kitchen area, a floor joist has been excessively notched beyond accepted limitations. Excess notching is unsafe. Be advised that excessive notching weakens a structural member and that the notched joists, beams or rafters may collapse under load. No signs of sagging or the framing was observed, however, for safety, I advise that additional framing be added to the joist to add integrity to the framing. (Notches in the top or bottom of joists should not exceed 1/6 the depth of the member and should not be located in the middle 1/3 of the span.)

notched floor joist

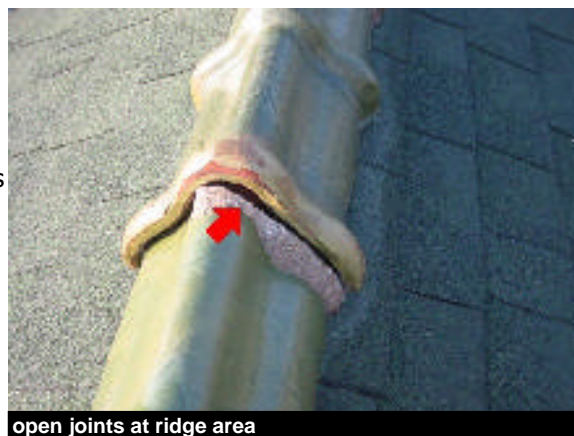
Maintenance Item: The mortar around the clay tile at the ridge is worn in several area.

These area are prone to leakage. We recommend these worn area be sealed with mortar as needed.

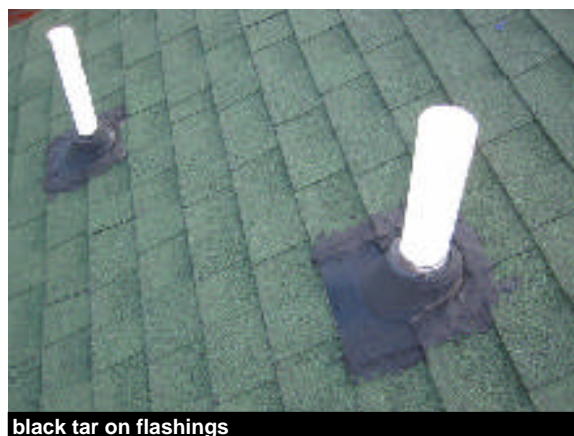
Monitor: As observed at the rear roof area, black colored roofing cement or roofing tar has been applied over the flashings at the plumbing vent pipes. flashing various roof penetration points or building intersections. Due to the roofing cement, the flashing beneath was not accessible for evaluation - true flashing condition at those areas covered by tar is undetermined. Be advised that a properly flashed roof penetration should not need to be coated with roofing cement. The tar may have been installed as preventative maintenance or to seal a flashing leak. While the area may not be leaking at this time, it does appear potentially problematic. We recommend that the area in question be monitored for leakage and that the tar be re-applied every year as it will degrade from exposure and unequal coefficients of expansion between dissimilar materials. If signs of leakage are discovered, then a roofer should be consulted to reappraise and repair the flashings as required to restore function.

black tar on flashings

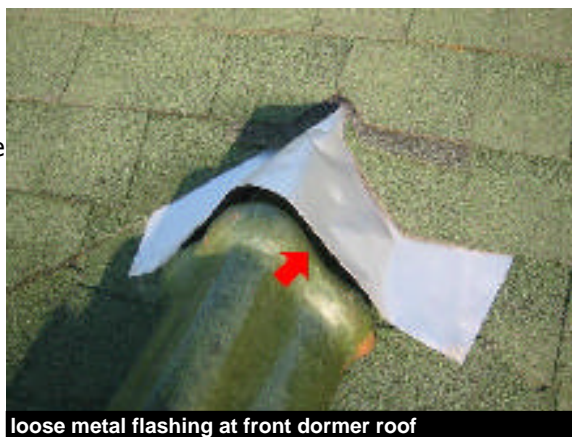
Repair: As seen above the roof at the front dormer roof and the main roof, there is a small piece of metal flashing that does not lay flat against the roof. Faulty flashing at the roof intersection may allow leakage. We recommend fixing/ sealing the flashing as needed to shed water from the opening in the roof.

loose metal flashing at front dormer roof

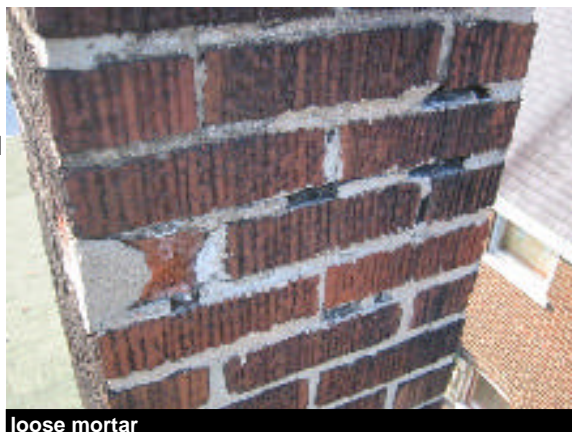
The visible areas of the chimney [from the roof line up] appeared functional and there was a rain cap installed. with exceptions noted, **Repair:** As viewed above the roof line, the chimney mortar joints have eroded open in some areas. If this condition is allowed to continue without repair, deterioration will be progressive until bricks will eventually loosen and fall causing unsafe chimney blockage or property damage. Due to exposure to the elements and neglected chimney cap maintenance, moisture has entered the brick causing the mortar to soften and erode. At this time, the chimney appears to only need simple re-

loose mortar

pointing (replacing the mortar between the bricks) of the mortar joints. We recommend a brick mason provide simple repair estimates. A detailed on roof close-up chimney inspection by a mason may reveal interior or exterior defects not disclosed in this report. After repairs, the chimney cap should be inspected every few years for cracks and patched as needed and we

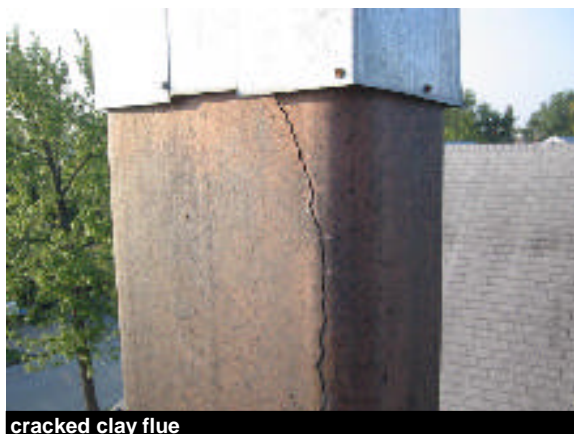
Repair: The clay tile flue liner at the top of the chimney has cracked. We recommend budgeting for repair of the type of crack as need to restore safe function of the chimney.

cracked clay flue

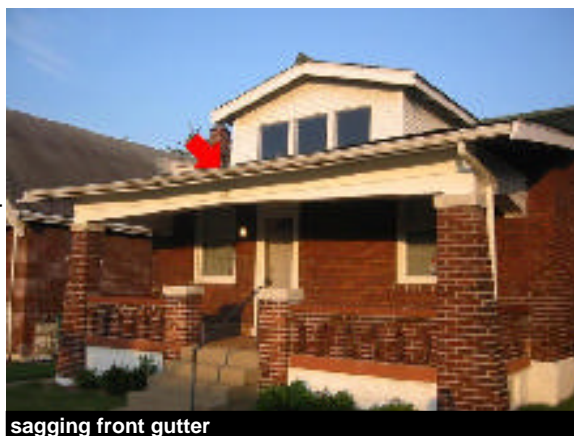
Repair: The gutter at the front of the house appears to be improperly pitched and is sagging in the middle of the gutter. The low spots in the gutter will retain water which may cause problems such as: spill over, back-ups, clogging or loosening due to excessive weight. We recommend the problematic gutter be removed and re-installed with proper pitch to restore function.

sagging front gutter

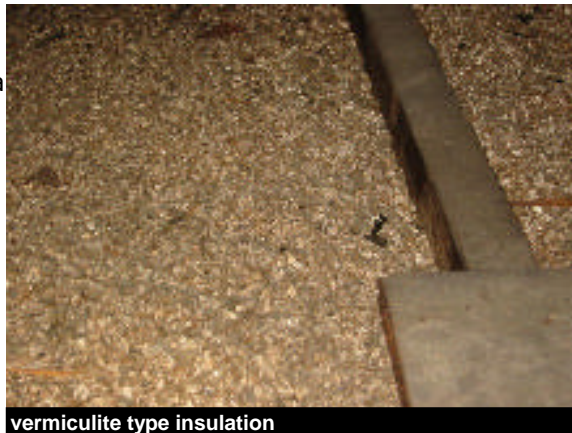
INSULATION There is a loose fill, silver & gold colored insulation material in the attic between the ceiling joists. The insulation appears to be a material known as vermiculite which is a possible safety concern. Be advised that this type of insulation may contain asbestos. Do not disturb the insulation as air born dust may be hazardous to your health. You may be wise to have the insulation tested for possible asbestos content prior to purchase. We recommend contacting a certified asbestos testing lab if further testing and evaluation is desired. There is an average of approximately 3-4 inches of insulation installed where measured which is below today's R-value standards. The 'R' in R-value stands for "Resistance" to heat transfer. The higher the number the better - up to a point.

vermiculite type insulation

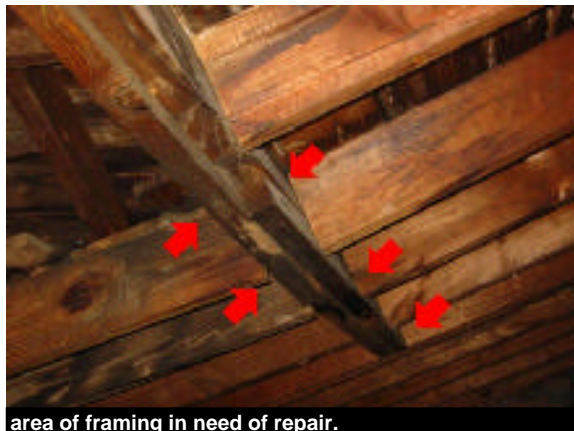
Repair: There is a section of moisture type damage as viewed in the attic under the front dormer roof. The water stains appear older and inactive, however repairs to the wood framing are needed to restore function to the framing. We recommend installation of metal connectors and adding additional framing where needed at any cracked or damaged wood as needed.

area of framing in need of repair.

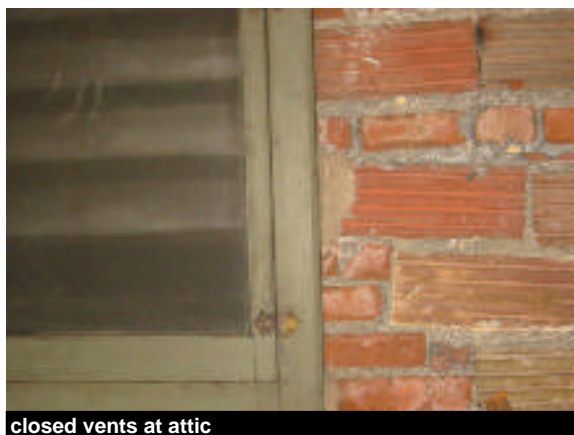
Repair: The windows over the gable vents on the left and right side of the attic were closed, therefore the attic has no means of ventilation. Insufficient attic ventilation will trap heat and humidity in the attic space causing higher cooling expenses and reducing roof design life. While the lack of ventilation may be typical for a home of this age, you would be wise to update the attic ventilation system now or at time of next scheduled roof replacement. A roofer can provide you with ventilation options and estimates for updating.

closed vents at attic

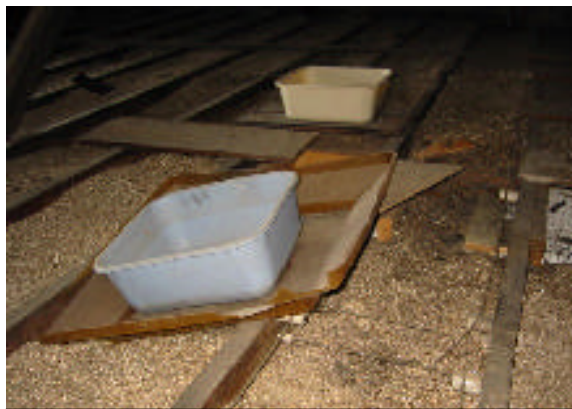
Consult Seller: As viewed in the accessible parts of the unfinished attic, several buckets or other containers were placed under the roof as "rain catchers". The containers appear to indicate previous roof covering or flashing leakage and amateur temporary measures to prevent interior water damage. I advise that you discuss the containers with the owner as roof repairs may already have been completed. The buckets were dry and appeared to be older.

older buckets in attic

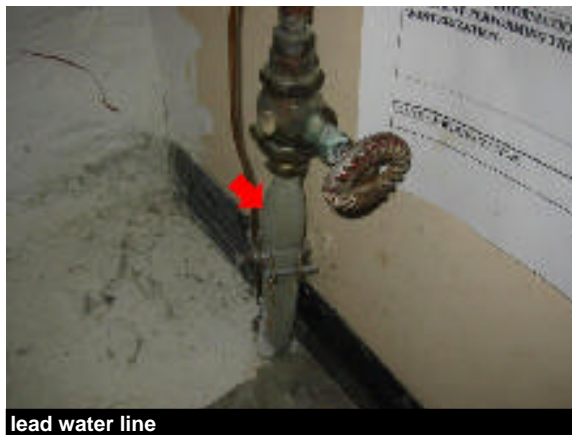
Inspection of the water service line running from the street main to the house revealed the presence of an old lead water pipe as viewed in the basement. While the lead supply line may still be functional, we recommend budgeting for its replacement in the future. For your peace of mind and safety, you may want to have the drinking water tested for lead content by a qualified environmental laboratory.

lead water line

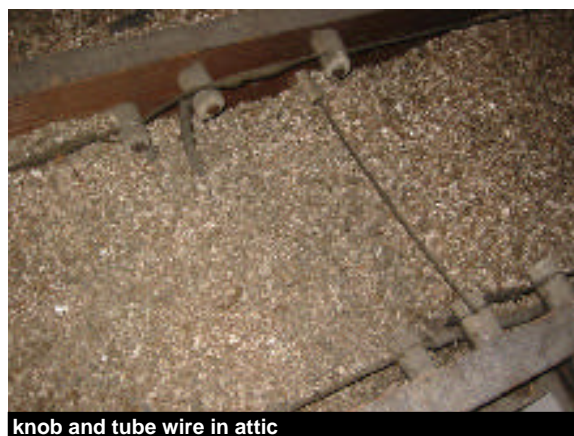
The branch circuit wiring appeared functional, with exceptions noted,
Note: The house has Knob and Tube wiring in use in some portions of the structure as viewed in the attic. If original insulation is still intact, and not improperly spliced, it is usually satisfactory for continued use, however, you may be aware that some insurance companies will not insure a home with knob and tube wiring nor a fuse panel. Due to the potential for overload or deteriorated conditions some insurance companies and lenders will require an upgrade of the electrical system therefore we suggest you discuss this type of older wiring with them prior to commitment.

Due to its age and increased circuit needs, it is suggested that considerations be given to upgrade the system to current standards. Estimates from a qualified electrician would be needed.

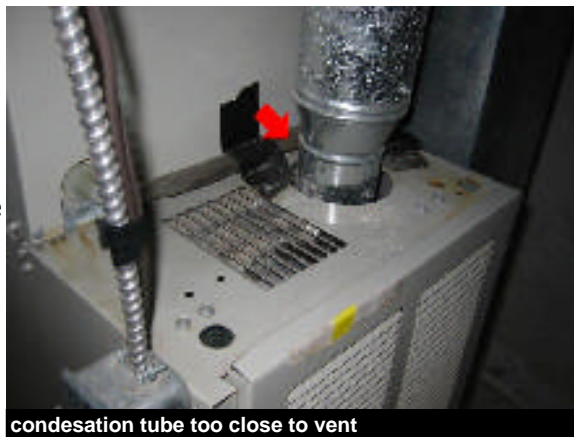
VENTING SYSTEM	<p>The visible areas of the flue vent piping were intact and secured at the connections with exceptions noted.</p> <p>Safety Concern: The flue vent piping was close to or in contact with combustible materials (the plastic condensation line for the evaporator coil). This condition is a fire hazard. We recommend eh condensation line be moved away from the vent pipe.</p>
-----------------------	---

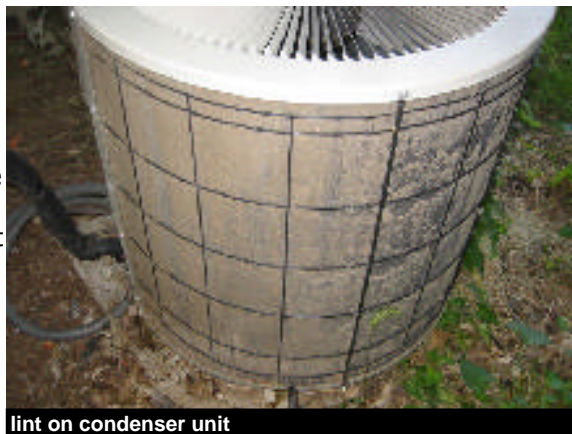
CONDENSING UNITS The condensing unit was functional, with exceptions noted.
Maintenance Item: A number of the coil fins of the condensing unit were dented This condition reduces the unit's overall performance. Minor dents in the fins can be combed out by a cooling technician. We suggest this condition be improved the next time the unit is serviced.

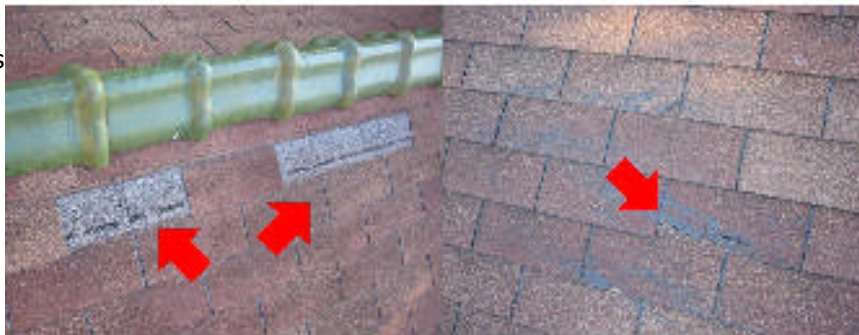
COMP. SHINGLE The roof covering material appears functional and in a condition that is consistent with its age and method of installation. There is normal granular wear and aging. We observed no signs of major deficiency of cause for

missing shingles / worn areas
