Inspection Report

Subject Property: 3631 Lawn Avenue, Saint Louis, MO 63109

Inspection Date: 09/22/2005

BenchMark Home Inspections, L.L.C

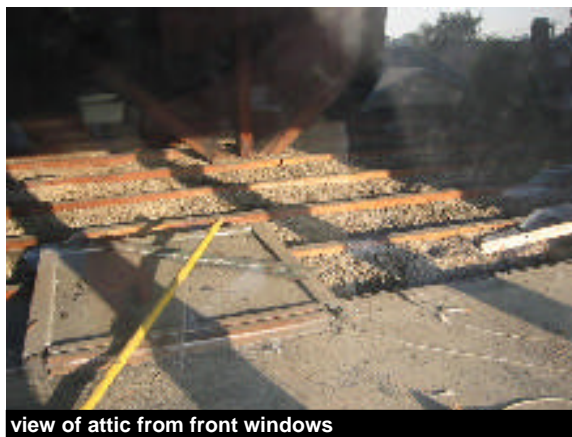
view of attic from front windows

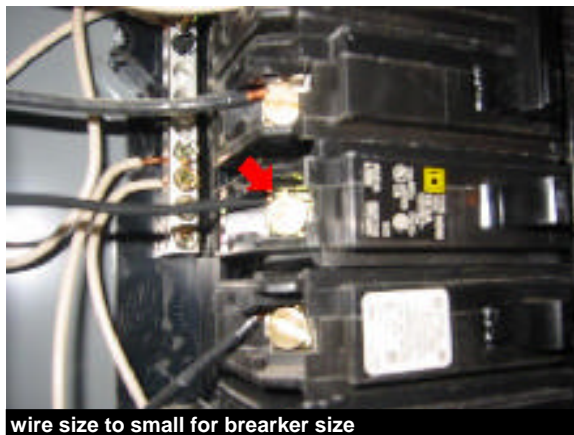
The branch circuit wiring appeared functional, with exceptions noted,
Note: The house has Knob and Tube wiring in use in some portions of the structure as viewed in the attic. If original insulation is still intact, and not improperly spliced, it is usually satisfactory for continued use, however, you may be aware that some insurance companies will not insure a home with knob and tube wiring nor a fuse panel. Due to the potential for overload or deteriorated conditions some insurance companies and lenders will require an upgrade of the electrical system therefore we suggest you discuss this type of older wiring with them prior to commitment.
